Turbine Tribune

New Heights for S.T. Cotter Turbine

Generator Inspections - Why Spend Money? Part 2

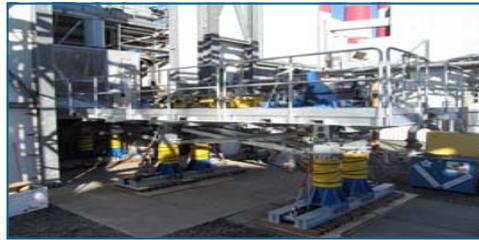
S.T. Cotter Turbine Services, Inc. went to new heights this fall...literally. Using our new, elevating, generator rotor pulling, trolley system (i.e. Runway), we were able to safely perform a rotor out inspection on an elevated, outdoor generator without having to pick and move the rotor.

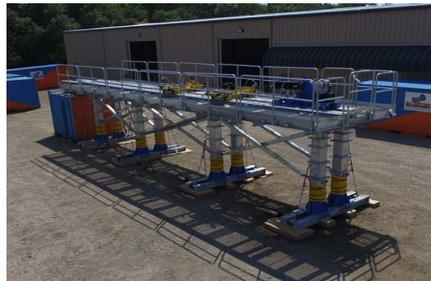
Runway platform during the first set up at the shop.

After approximately twelve hours of runway assembly, we were ready to go forward with the rotor removal portion of the project. With confidence and ease, we pulled the rotor out of the stator stopping only to install the carriages under the rotor and to make a side shift move using the hydraulic trolley. We had the rotor in position, locked down, and turned over to the generator test crew in short order.

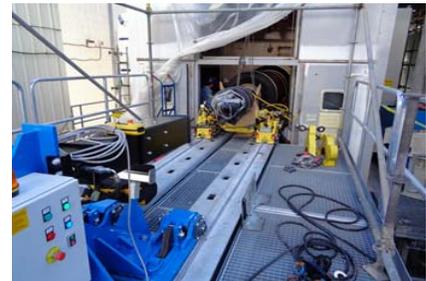
The Runway's first project was a success!
